# BIOQUELL's **CLARUS**<sup>™</sup> technology

## Hydrogen Peroxide Vapour

### Material Compatibility:

### Issues and facts

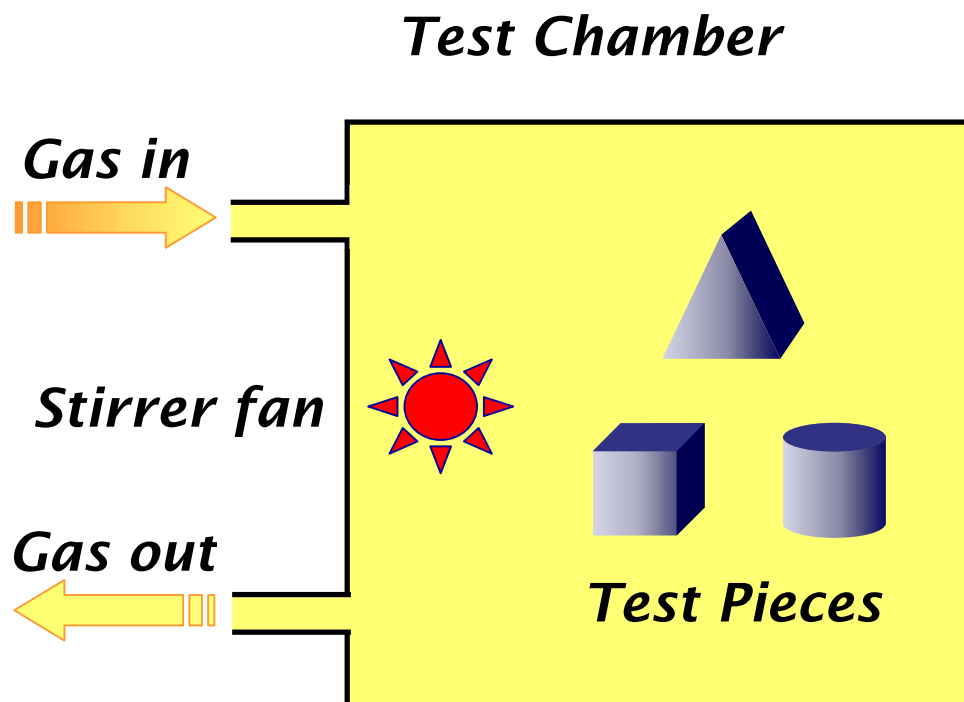
## Individual Material Tests: Test methodology

### Test Conditions

*Gas concentration : 1000 ppm*

*Exposure time : 140 hours*

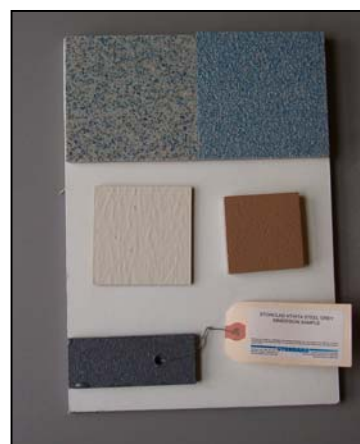
### Sheet 033

<b>Material</b>	<b>Ceramic tiles</b>
<b>Description</b>	Five STONHARD ceramic tiles, used for wall and flooring were tested (as pictured, below)
<b>Observations</b>	None of the tiles showed any signs deterioration or visible deposits on the surfaces
<b>Conclusions</b>	Hydrogen peroxide vapour has no apparent effect on ceramic tiles.
<b>Recommendations</b>	Ceramic tiles are recommended as suitable materials in a room regularly decontaminated by hydrogen peroxide vapour.
<b>Method of Testing</b>	<p>A Clarus™ R Generator was placed inside a room of approximately 30 m<sup>3</sup>. The ceramic tiles were placed inside the room.</p> <p>The enclosure was sealed and samples were subjected to 85 back-to-back cycles. A typical cycle achieved a concentration of &gt;500ppm for 32 minutes, thus the samples were subjected to &gt;500ppm for 43 hours. The samples were then removed and inspected.</p> <p>The inspection consisted of a detailed visual inspection and a mechanical inspection to ascertain whether the material had been adversely affected during the exposure.</p>

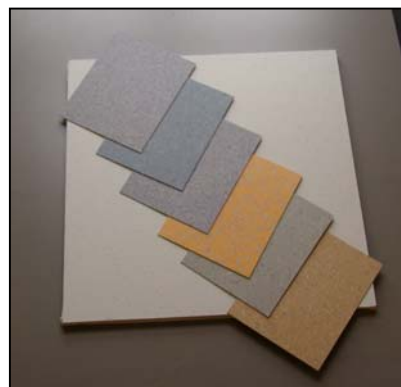
<b>Material</b>	<b>Rubber floor tiles</b>
<b>Description</b>	Six 2mm Noraplan rubber floor tiles were tested (as pictured, below)
<b>Observations</b>	None of the tiles showed any signs deterioration or visible deposits on the surfaces.
<b>Conclusions</b>	Hydrogen peroxide vapour has no apparent effect on rubber floor tiles.
<b>Recommendations</b>	Rubber floor tiles are recommended as suitable materials in a room regularly decontaminated by hydrogen peroxide vapour.
<b>Method of Testing</b>	<p>A Clarus™ R Generator was placed inside a room of approximately 30m<sup>3</sup>. The tiles were placed inside the room.</p> <p>The enclosure was sealed and samples were subjected to 64 back-to-back cycles. A typical cycle achieved a concentration of &gt;500ppm for 30 minutes, thus the samples were subjected to &gt;500ppm for 32 hours. The samples were then removed and inspected.</p> <p>The inspection consisted of a detailed visual inspection and a mechanical inspection to ascertain whether the material had been adversely affected during the exposure.</p>

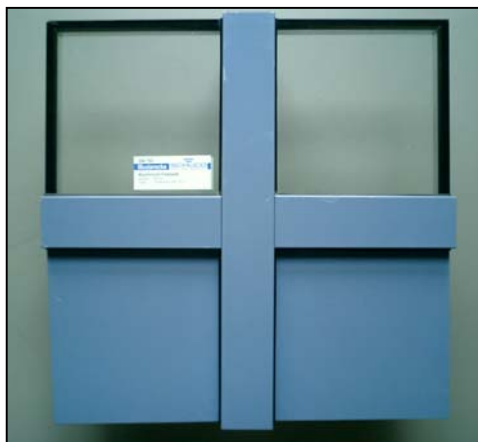
### Sheet 037

<b>Material</b>	<b>Window frame (double glazed)</b>
<b>Description</b>	Two double glazed plastic window panes and their associated coated aluminium frame (as pictured, below)
<b>Observations</b>	Neither the plastic windows nor the frame showed any signs deterioration or visible deposits on the surfaces. No glazing was evident on the window panes.
<b>Conclusions</b>	Hydrogen peroxide vapour has no apparent effect on double glazed windows or frames.
<b>Recommendations</b>	Double glazed windows are recommended as suitable materials in a room regularly decontaminated by hydrogen peroxide vapour.
<b>Method of Testing</b>	<p>A Clarus<sup>™</sup> R Generator was placed inside a room of approximately 30m<sup>3</sup>. The window frame was placed inside the room.</p> <p>The enclosure was sealed and the sample was subjected to 64 back-to-back cycles. A typical cycle achieved a concentration of &gt;500ppm for 30 minutes, thus the sample was subjected to &gt;500ppm for 32 hours. The samples were then removed and inspected.</p> <p>The inspection consisted of a detailed visual inspection and a mechanical inspection to ascertain whether the material had been adversely affected during the exposure.</p>

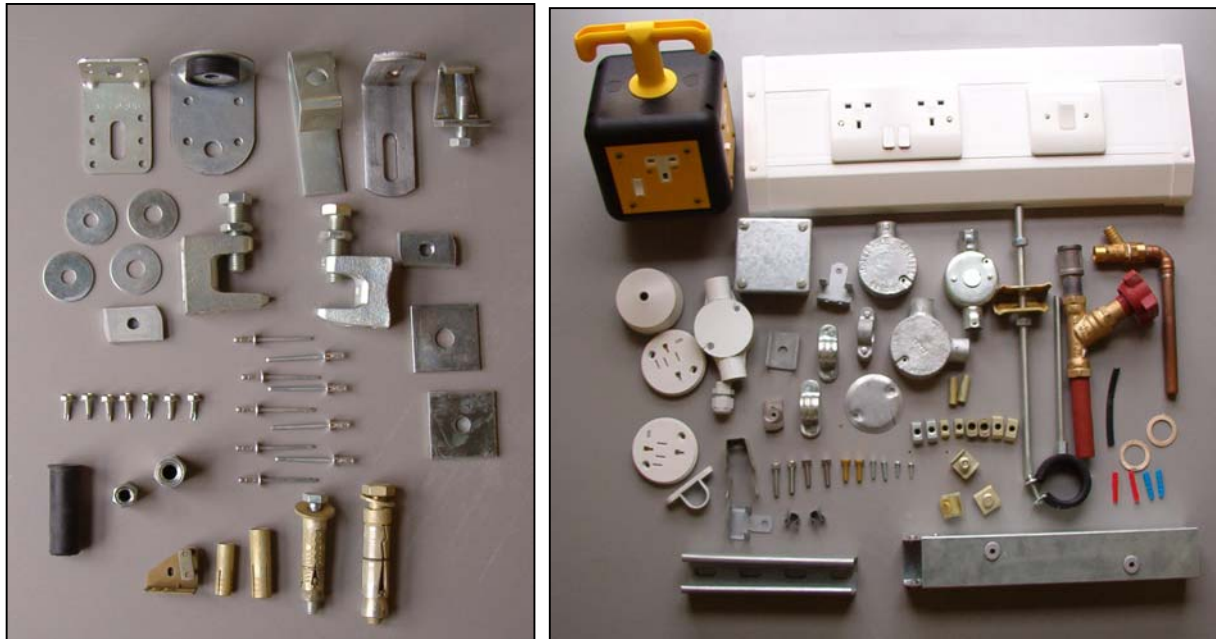
The materials tested are pictured below:

Passivated (coated) metal materials showed a slight discolouration. This is shown by the face on which the component has been resting still has a shiny finish whilst the exposed sides have lost their glossy finishes. Similarly, discolouration of copper was noted. These purely aesthetic changes are due to the strong oxidising properties of hydrogen peroxide vapour. All other materials showed no signs of degradation and were free of viable residues.

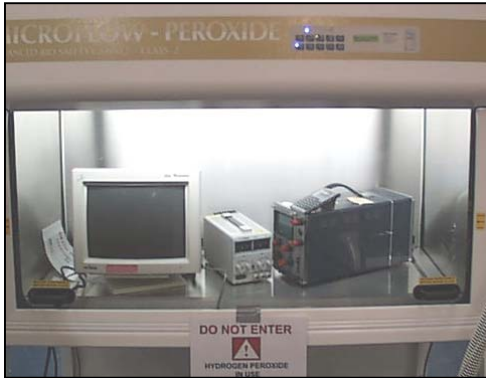
*A range of instruments have been tested both dormant and powered without any failures*

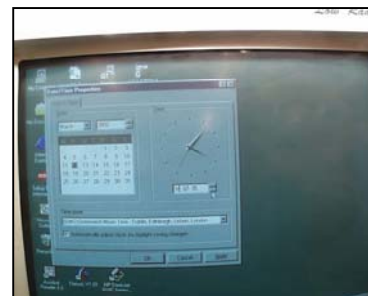
***Computer VDU, oscilloscope, power supply, solar powered calculator, lap top computer, telephone.***

*Slight fogging occurred during the gassing phase as vapour condenses on the cold glass*

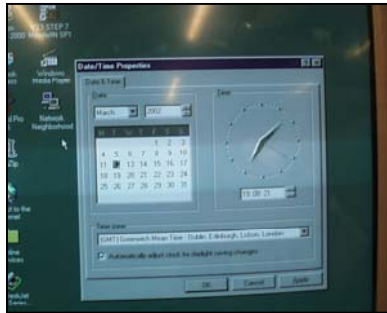
*At the end of the aeration period the equipment is still functioning normally*

In both cases the results were conclusive that the introduction of hydrogen peroxide gas at 60°C had no effect on the functionality of the electrical equipment. Also **no surface distortion/discoloration was found with the casing**. Fogging on cold surfaces only occurred during the gassing phase and dissipated soon after the aeration cycle began.

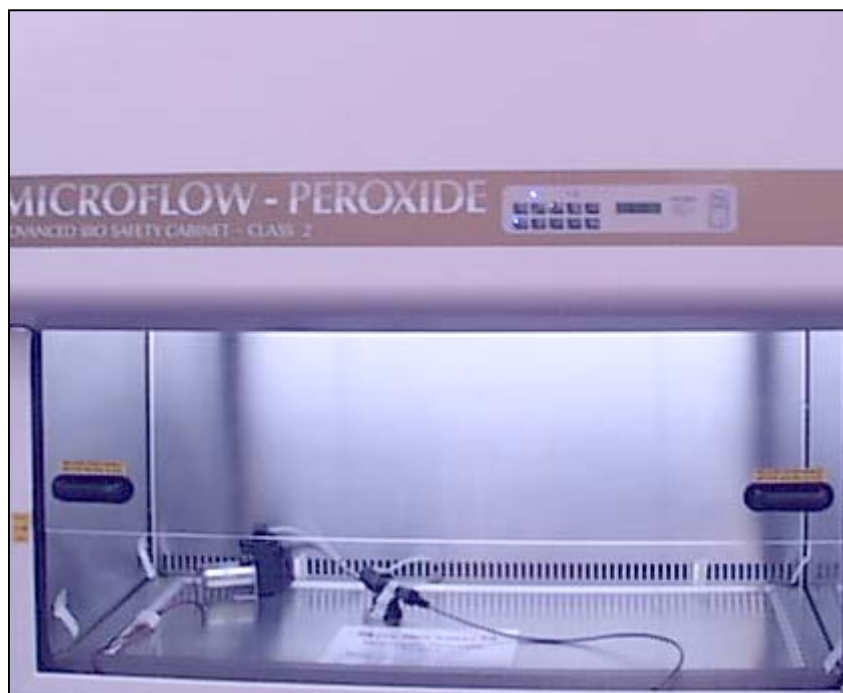
## Corrosion testing

### 860 gassing cycles over a 4 month period

- No electronic failures
- Electrical wiring undamaged
- Stainless steel unaffected
- Painted mild steel unchanged
- Exposed PCB not damaged

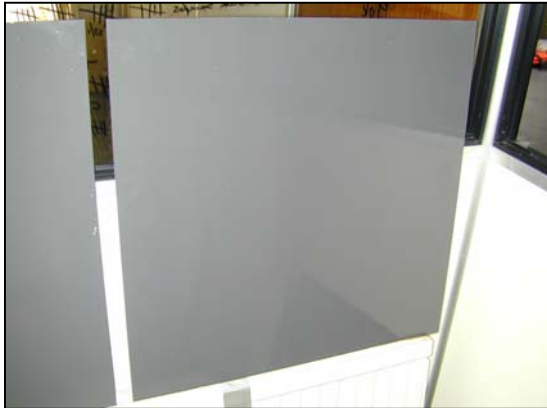
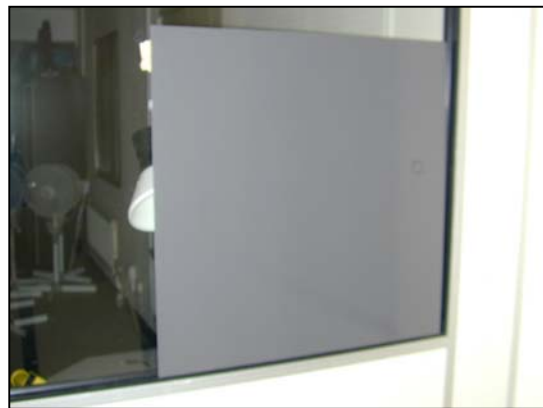
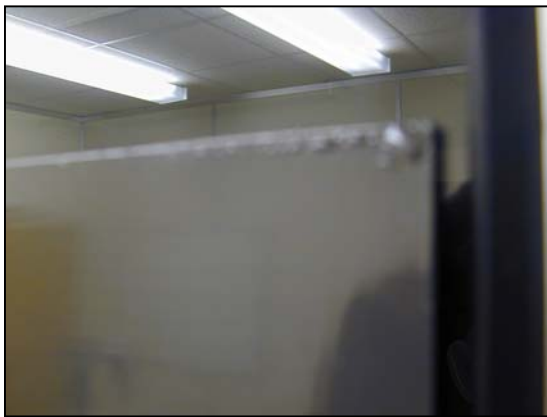
**No.1 (galvanised steel with undercoat and topcoat) before and after gassing**

(a) Before

(b) After

(c) (left) Close-up of bubbling on the edge of the paint sample

The trade paint does bubble around the edges when subjected to multiple hydrogen peroxide vapour exposures. The bubbling was not apparent on the flat painted surfaces of the materials. This provides evidence that the bubbling is caused by hydrogen peroxide vapour diffusing under the painted surface at the edges, decomposing to liberate oxygen and hence causing an expansion effect on the paint surface. Bubbling was much more prevalent on the galvanised steel substrate than the mild steel. This would lead to the conclusion that there is a better adherence of the paint to the mild steel than the galvanised steel, limiting the diffusion of the hydrogen peroxide into the paint.

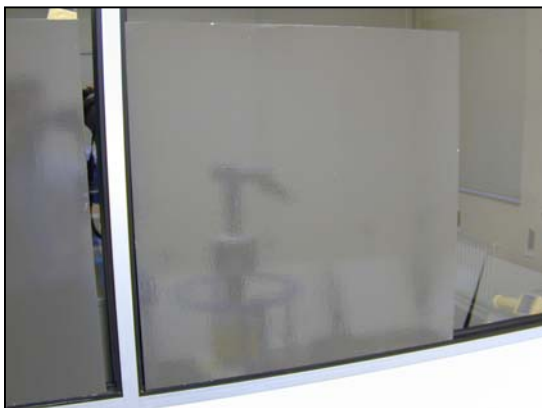
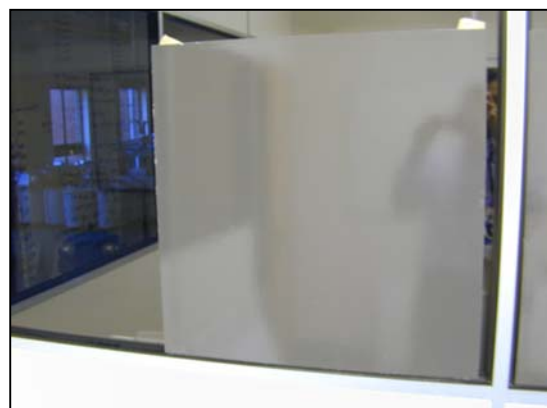
**No.2 (galvanised steel with undercoat, topcoat and varnish) before and after gassing**

**No bubbling was witnessed on this substrate / paint combination**

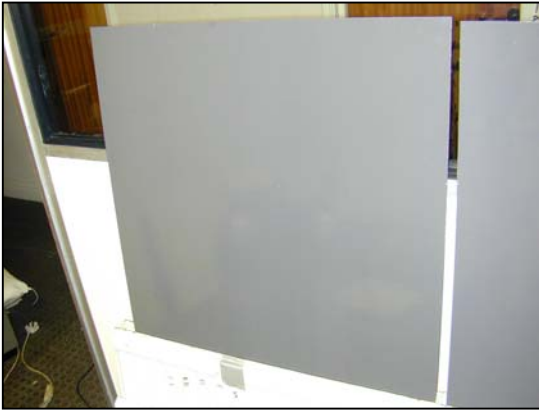
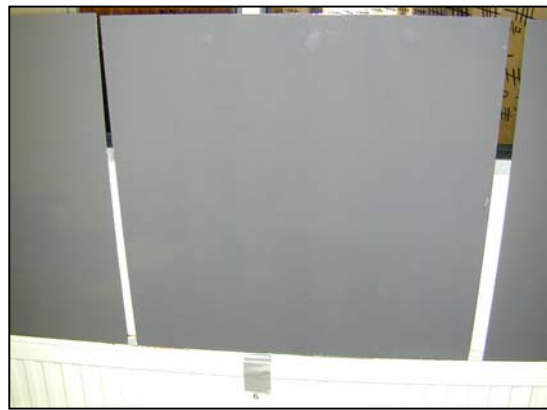
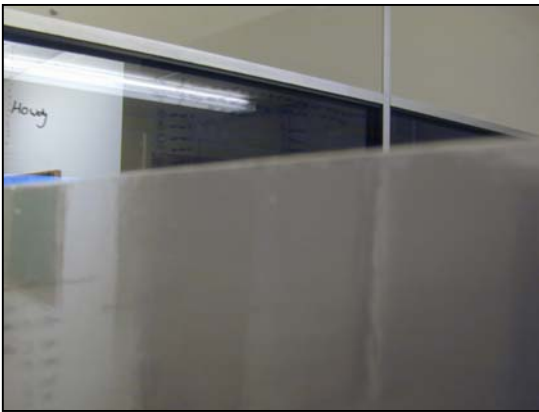
**No.3 (mild steel with undercoat and topcoat) before and after gassing**

(a) Before

(b) After

(c) (left) Close-up of bubbling on the edge of the paint sample. Bubbling was extremely fine - very hard to pick up with a camera.

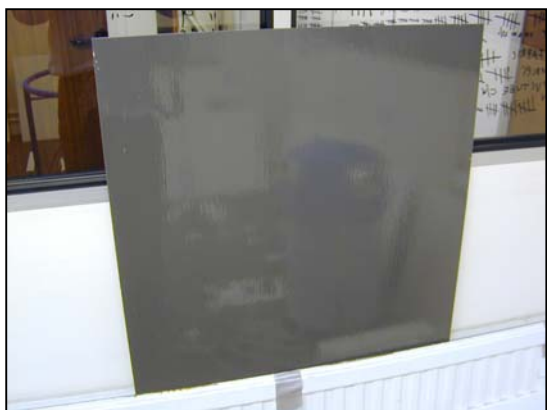
**No.4 (mild steel with undercoat, topcoat and varnish) before and after gassing**

**No bubbling was witnessed on this substrate / paint combination**

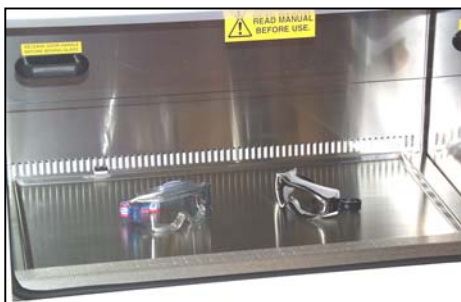
The goggles showed low levels of out gassing as they were subjected to 20 continuous gassing cycles

*Eye goggles  
positioned in safety  
cabinet for gassing*

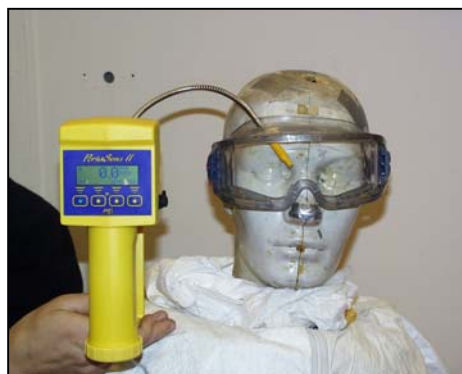
***Out-gassing  
measurement taken  
from eye goggles in  
position of normal use***

The second set of tests showed that the goggles required additional aeration to the standard gassing cycle to ensure that out gassing is minimised. It is recommended that a procedure be developed to aerate the goggles in the safety cabinet for a time after the gassing cycle has been completed.
